Cockle's Bike Shop

A late medieval timber framed building

BUILDING CONSERVATION JOURNAL

No. 20 Summer/Autumn 1998

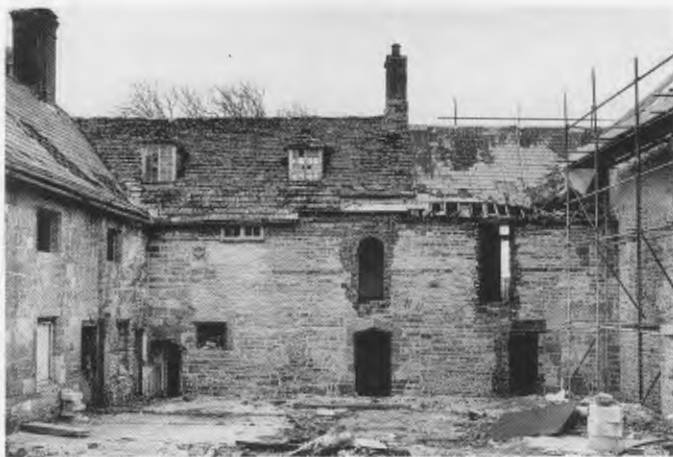
three major phases and numerous more minor alterations. The range in the centre, although extensively altered, is the earliest of the three, the evidence for this assumption being a blocked two-light mullioned window with traceried heads at first-floor level at the extreme right behind the scaffolding, and a blocked two-

centred opening low down near the left side of the range. The position of the latter is an indication that the ground level has been raised by at least three to four feet prior to the creation of four-centred openings at the present level. The blocked two-light traceried window is of an early type and *in situ*, an indication that the range probably dates from the early 15th century. Another blocked mullioned window at the far left of the façade and a reset Tudor rose motif alongside are also suggestive of a 15th century date. The higher rubble range to the right is later as it butts up against the right jamb of the earlier two-light window and there is a construction or straight joint marking the point where the range was added. Late perpendicular windows in the higher range indicate it was added in the 16th century. The range on the left of the photograph is later still, having ashlar walls and regular fenestration consisting of mullioned windows with recognisably 17th century mouldings.

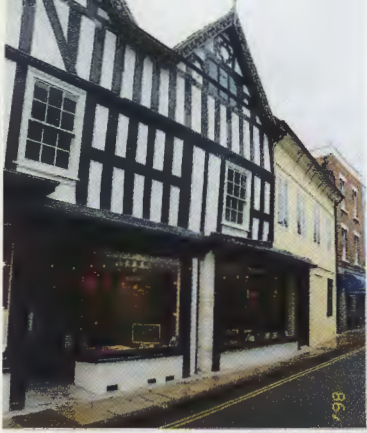
◀ *Front elevation
2 and 3 Milk Street*

The timber frame to the front wall was in a particularly poor condition with many decayed studs, posts and rails which were repaired using locally felled green oak. Many of the infill panels in the close studding had been crudely made up in the 1930s with engineering bricks (with frogs) laid on their sides in 1:3 cement mortar. Gaps had opened up between the bricks and the timber frame members and it was agreed with English Heritage that these could be replaced with wattle and daub.

Where other panels were found to be defective or where they had to be removed for extensive repairs to the frame members, these have been reinstated using oak or chestnut cleft lathing and a daub of clay, cow dung, lime, sand and goat hair. Where the panels had hazel twig laths these were replaced like for like.

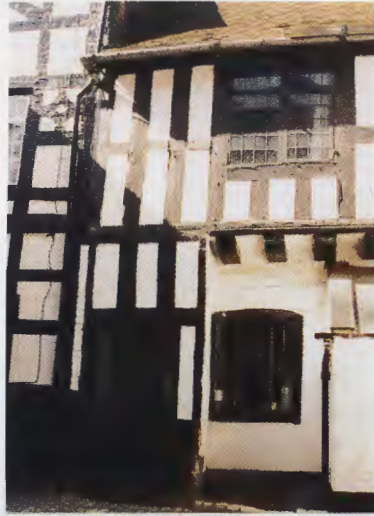
When the brick and glass extension was removed, the oak framing to the shop front was found to be heavily decayed with wet rot and death watch beetle. The frame was repaired by piecing in new timbers to replace the worst decayed material. Archaeological evidence established that the shop front had

*Medieval shopfront
before opening up* ▶

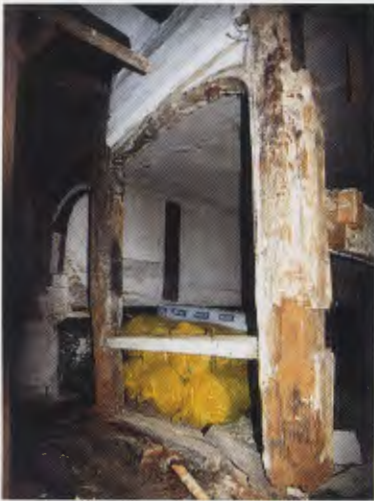
◀ *Medieval shopfront
after opening up*

mutilated by the insertion of a casement window, the remains of the other had been removed in the work carried out in the 1930s. Sufficient evidence remained in the form of mortises and other features in the remaining timbers to enable the window to be remade and reinserted.

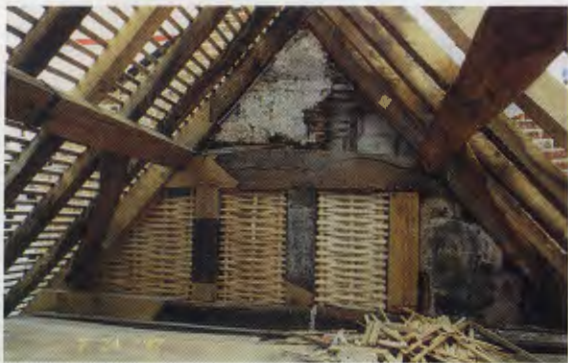
Together with the rest of the building, the roof structure had fallen into serious disrepair. Purlins had broken, roof braces were missing and others were decayed beyond repair. The deflection in the purlins was so exaggerated and had occurred over such a long period of time that the rafters had 'bent' with the deflection. Where the purlins were judged to be sound enough to retain the temptation to level up the depression in the tiled coverings was resisted. Where new oak purlins had to be introduced the rafters needed to be cut on the line of the purlins to remove the bow in the timbers.

Medieval roof undergoing repair

Reclaimed materials were not used on the project. Where insufficient suitable tiles remained to cover a whole roof slope, new Keymer hand made clay tiles were used. The clay tiles were laid and torched onto new timber battens with lime:sand:hair torching. Thus the traditional construction and original appearance of the underside of the roof structure has been conserved, and remains a dominant feature of the interior of the building.

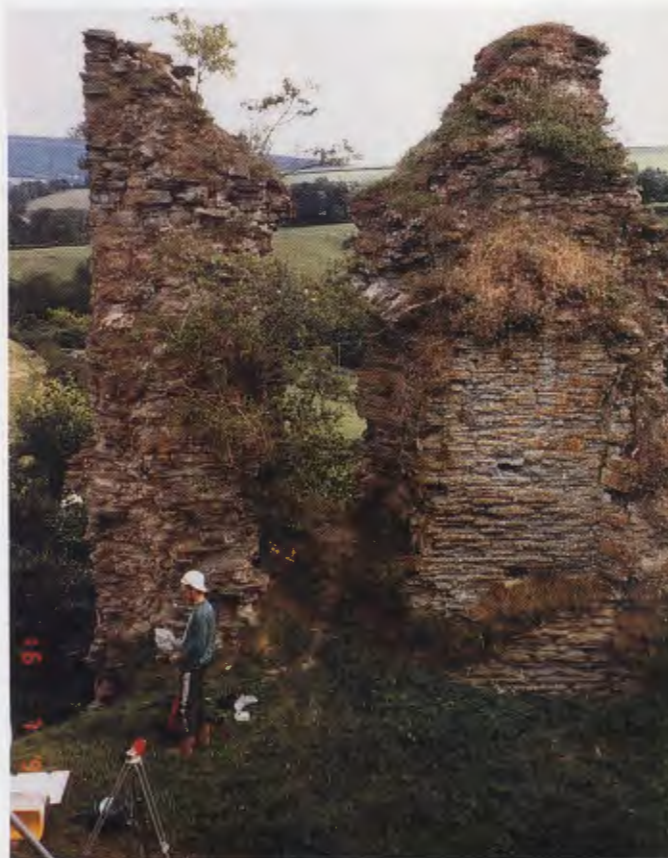
Section of ruin being recorded prior to consolidation works

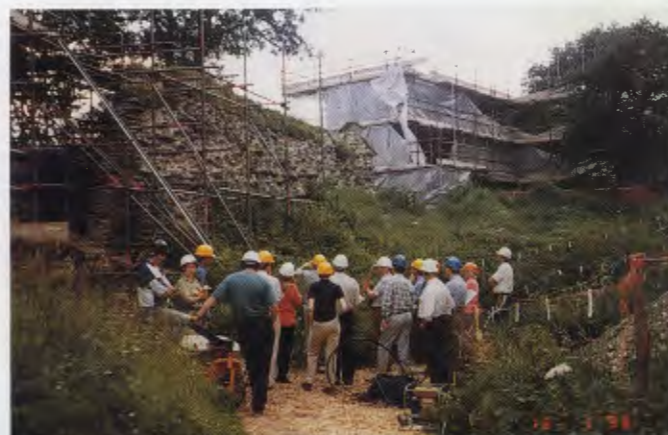
Members looking at works in progress; 'soft tops' re-established

The works have included the removal of vegetation off the tops of the walls, maintaining it during the consolidation works and then replanting it. Expecting this to be a specialist item it was surprising to be told that one of Capps & Capps own operatives carries out this work under the direction of a consultant ecologist. A successful re-establishment of the earlier 'soft tops' was proof to it being done correctly.
