# Building Conservation Journal

In search of a conservation plan for Brymbo Steelworks

Building Conservation September 2009

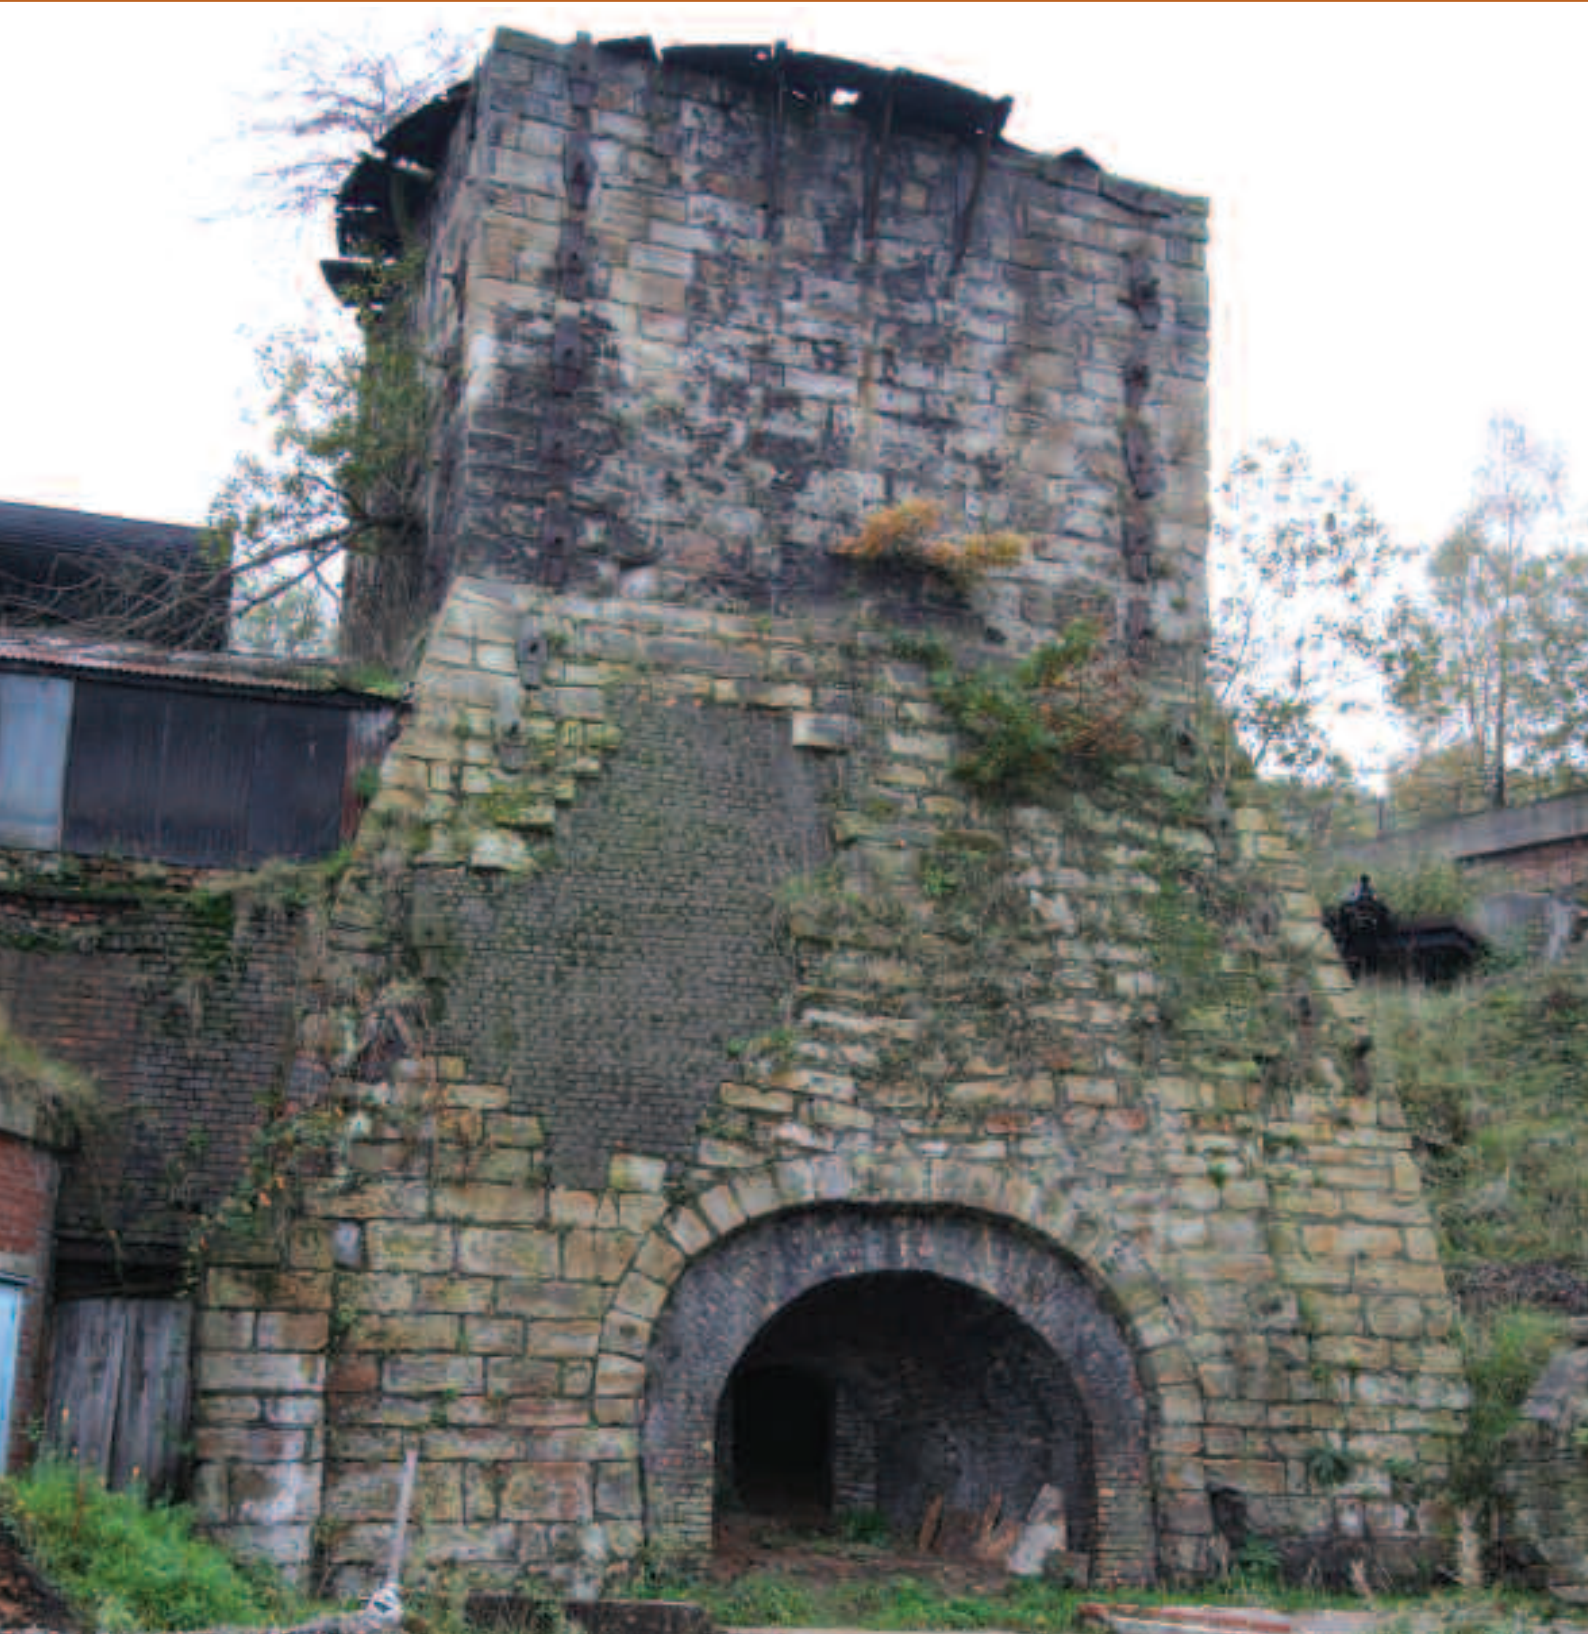
**ISSN:** ISSN 1469-5421 (Print) ISSN 1759-3379 (Online) **Front Cover:** The historic No.1 blast furnace at Brymbo Steelworks dates back to 1794 and the era of John Wilkinson, a pioneer in the use of cast iron. The buildings are gently decaying and will be lost forever without a conservation plan © Peter Napier

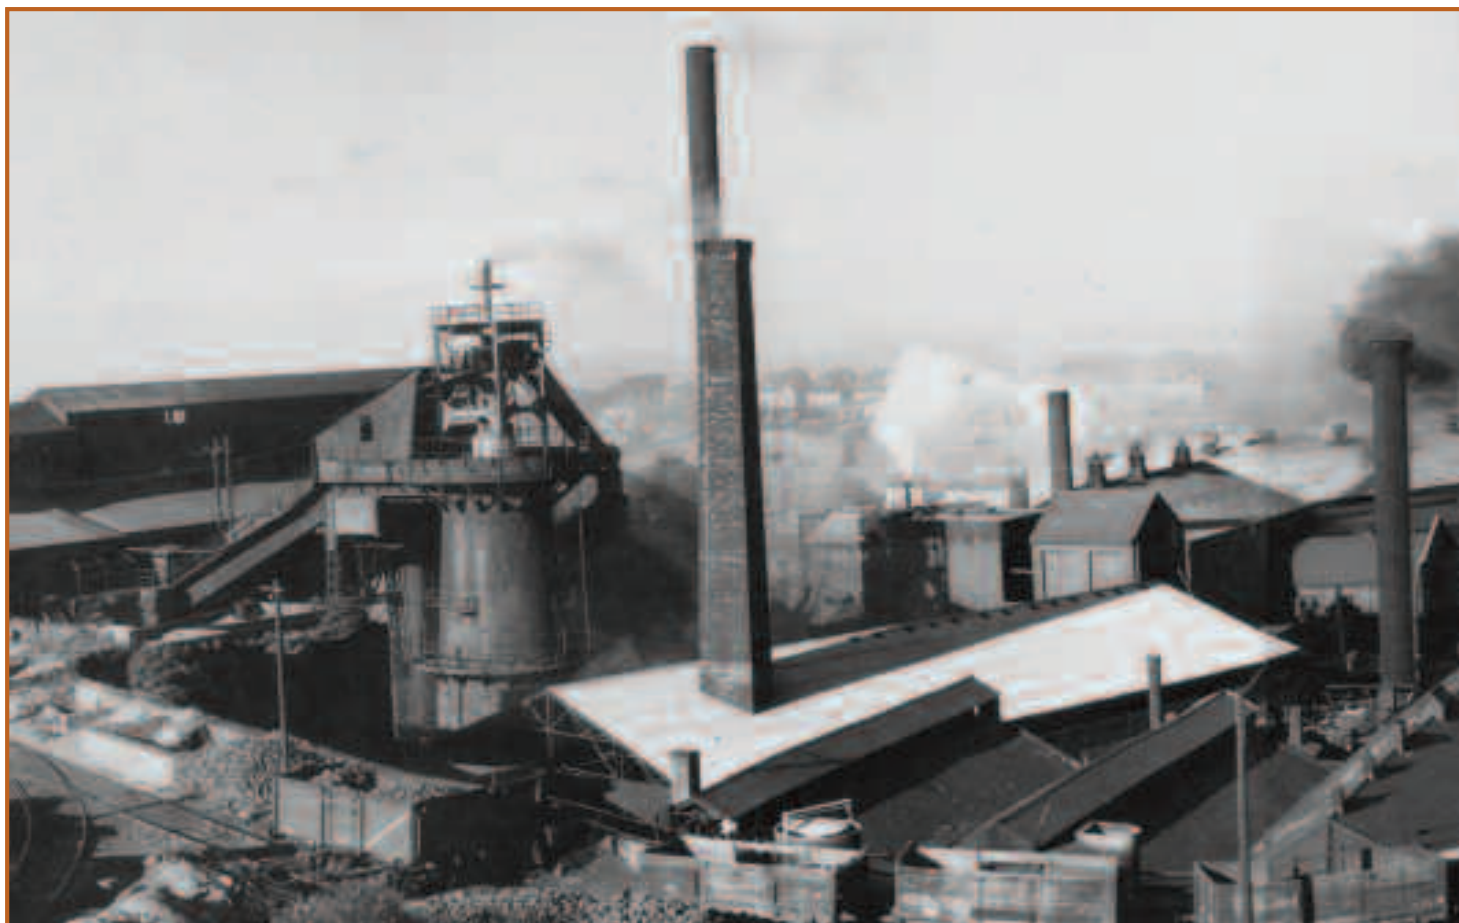
The ironworks itself is not unique, but the site is of exceptional interest, with all the features of an intact, original, mid-to-late 18th century ironworks, including the blast furnace; the foundry and casting floor; the workshop where the casting patterns were made; the original 18th century road through the site, which was diverted by the development of Brymbo from ironworks to steelworks; the early-18th century agent's house; the track bed of the railway line, and

the colliery that produced the coal for the blast furnace. Add to this the great crested newts and other flora and fauna that inhabit the site and you have some insight into the built and natural heritage value of this site.

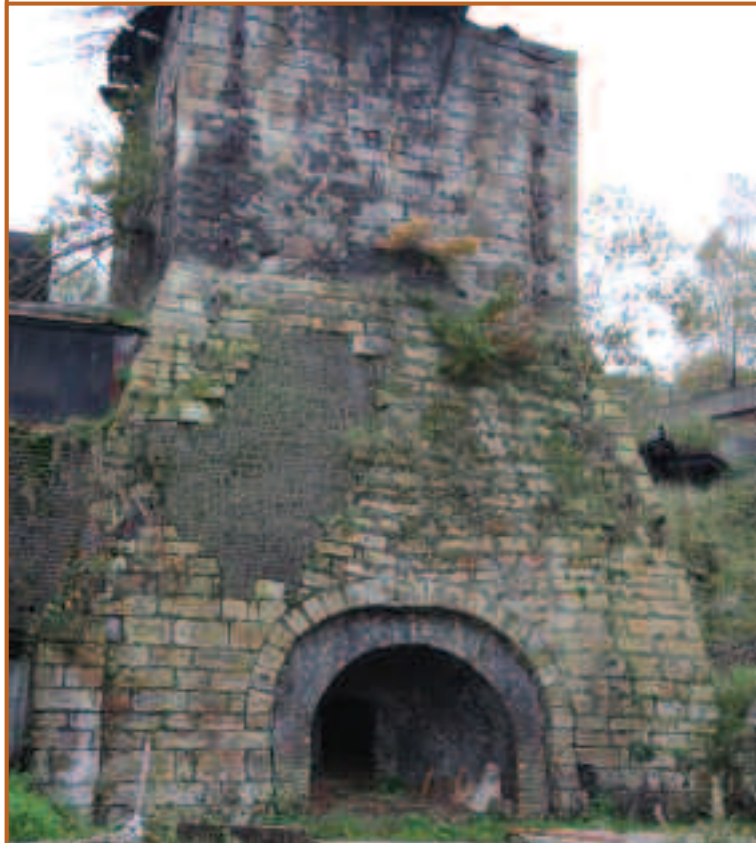
No.1 blast furnace, known locally as 'Old Number One', (1794) is a scheduled monument. This is a stone structure, open at the top to receive iron ore, coal and other materials. At the bottom are three arched openings used for removing ash and slag, tapping off the molten iron and injecting the blast of air from a nearby engine house now gone.

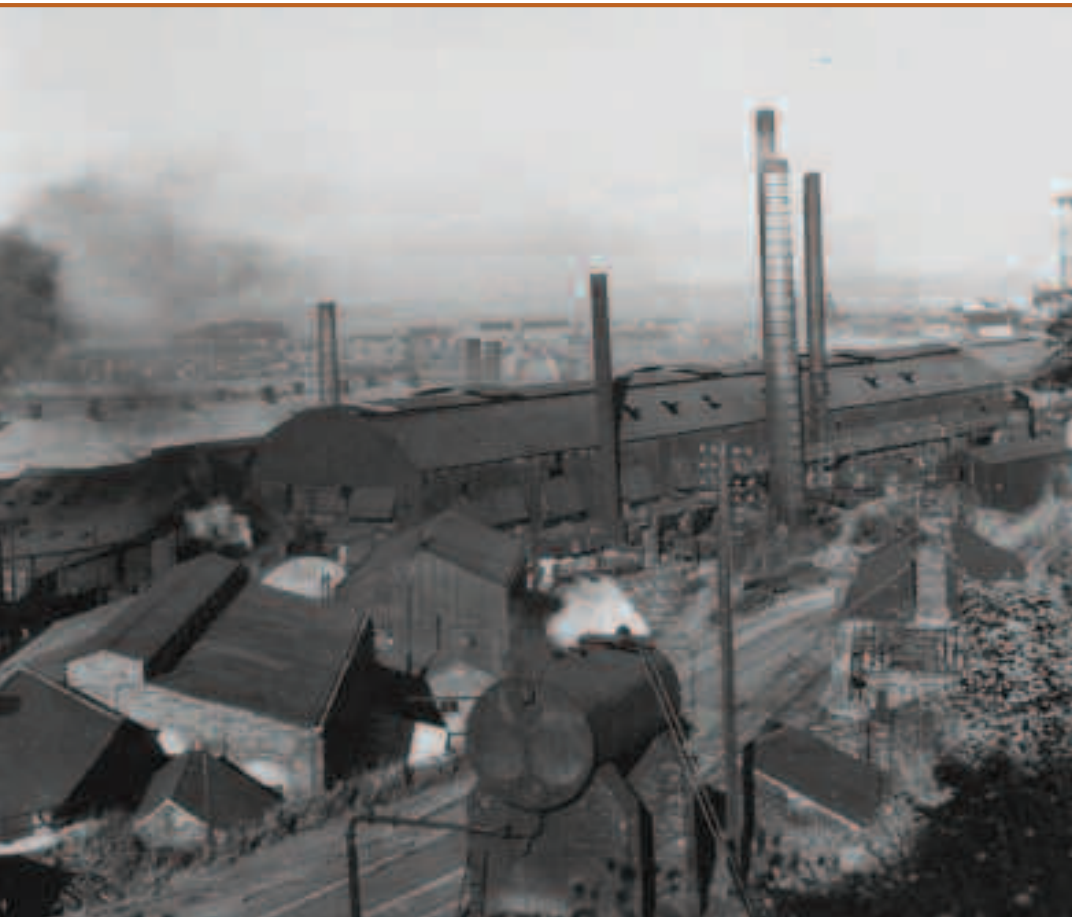
View of the ironworks in the mid-20th century. The agent's house (see page 6) is on the right and the No.1 blast furnace on the left. The foundry is at the front centre and the machine shop is just to the right of centre. Everything in the background has now gone.

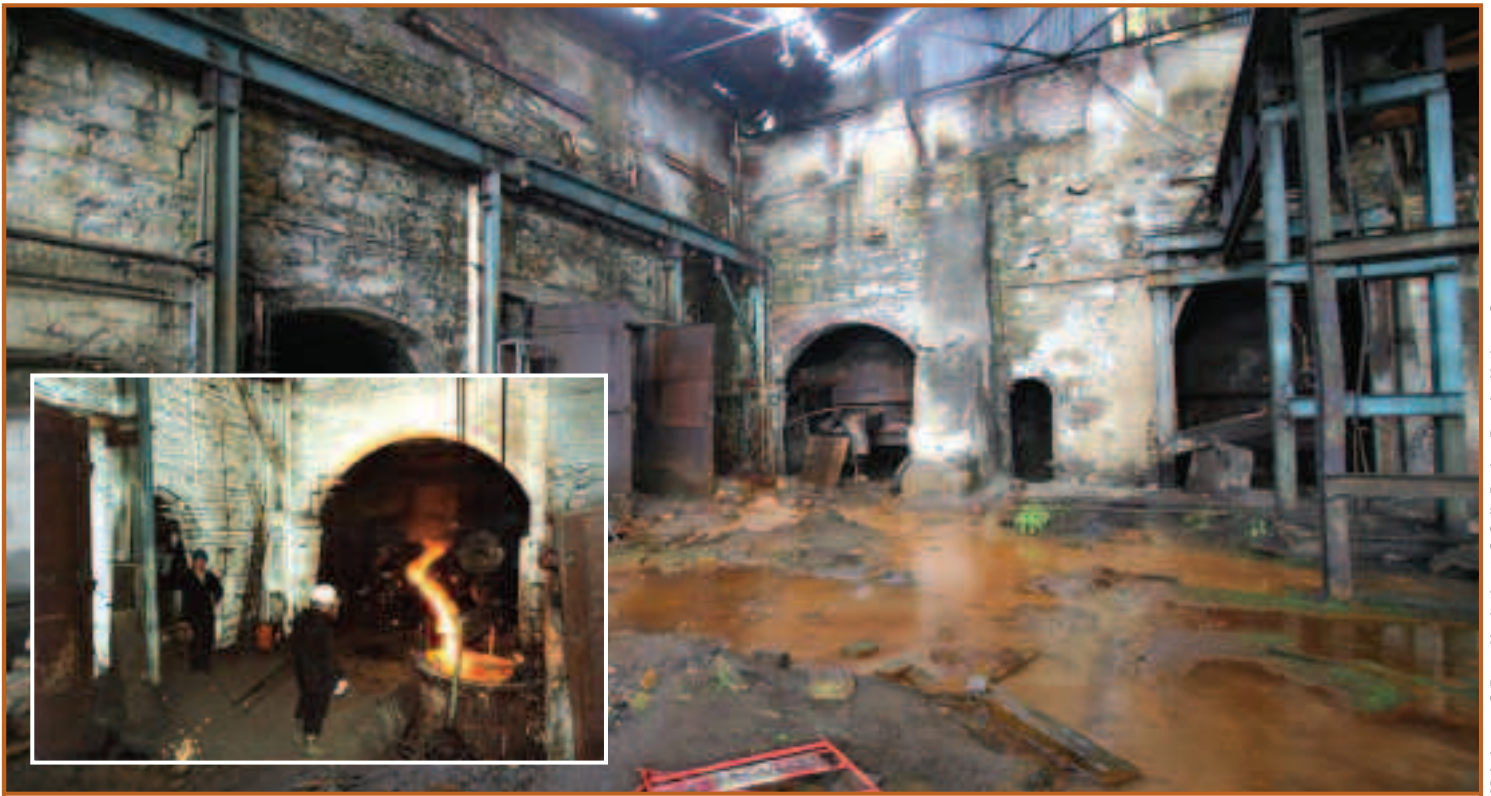
Part of the foundry in its present state and (inset) the furnace in use in the 20th century. Some elements of the original 18th century external walls survive.

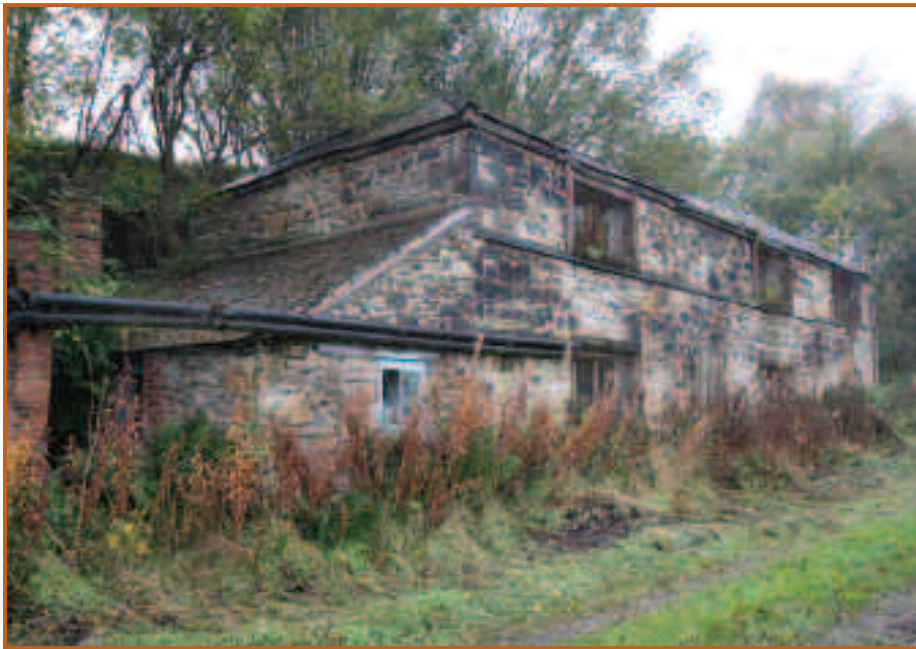
The agent's house (1794 or earlier); is a Grade II\* listed building. This is a two-storey building situated on the south side of the heritage area. It has stone walls under a hipped slate roof and was extended at some stage at its west end, using materials of construction and design to match the original building.

There is some conjecture as to whether this building pre-dates the John Wilkinson era. It is thought possible that it may have been the land agent's house for the Brymbo Estate when it was bought by John Wilkinson, in which case it would predate the building of the original ironworks by some years.

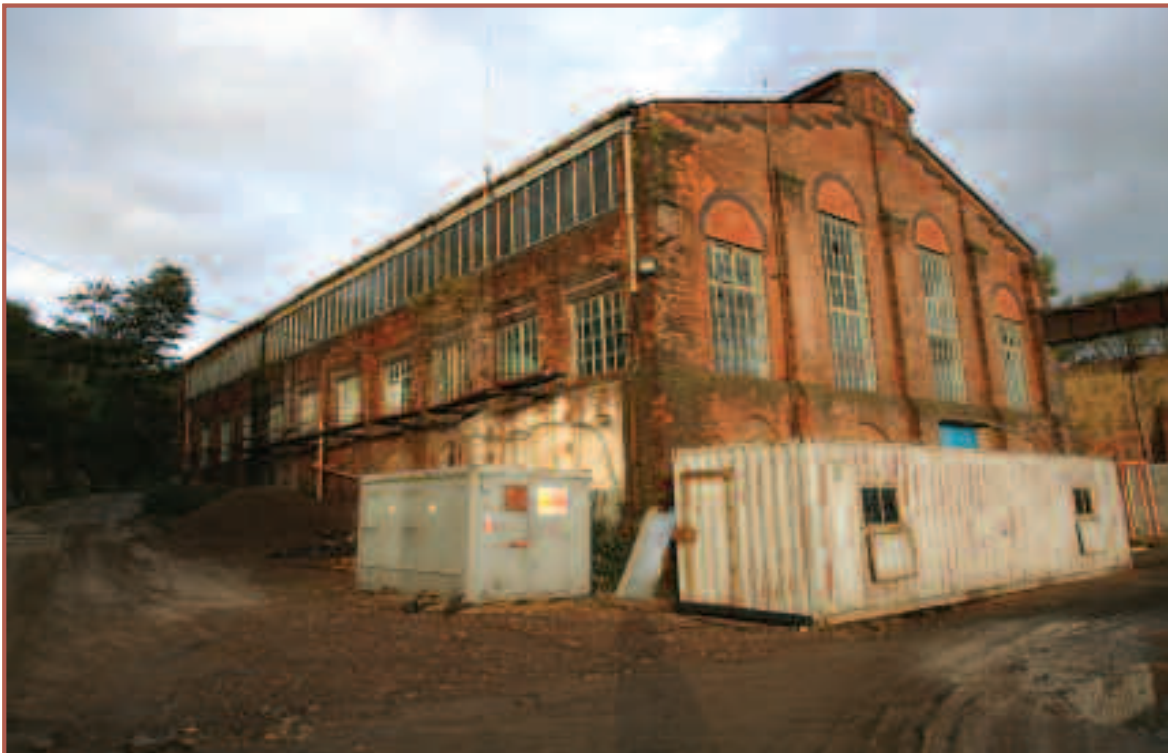
Machine shop (1920). This building, though not listed, is a very fine example of the industrial buildings of its time. Inside are the remains of a stone wall that survives from the John Wilkinson era.

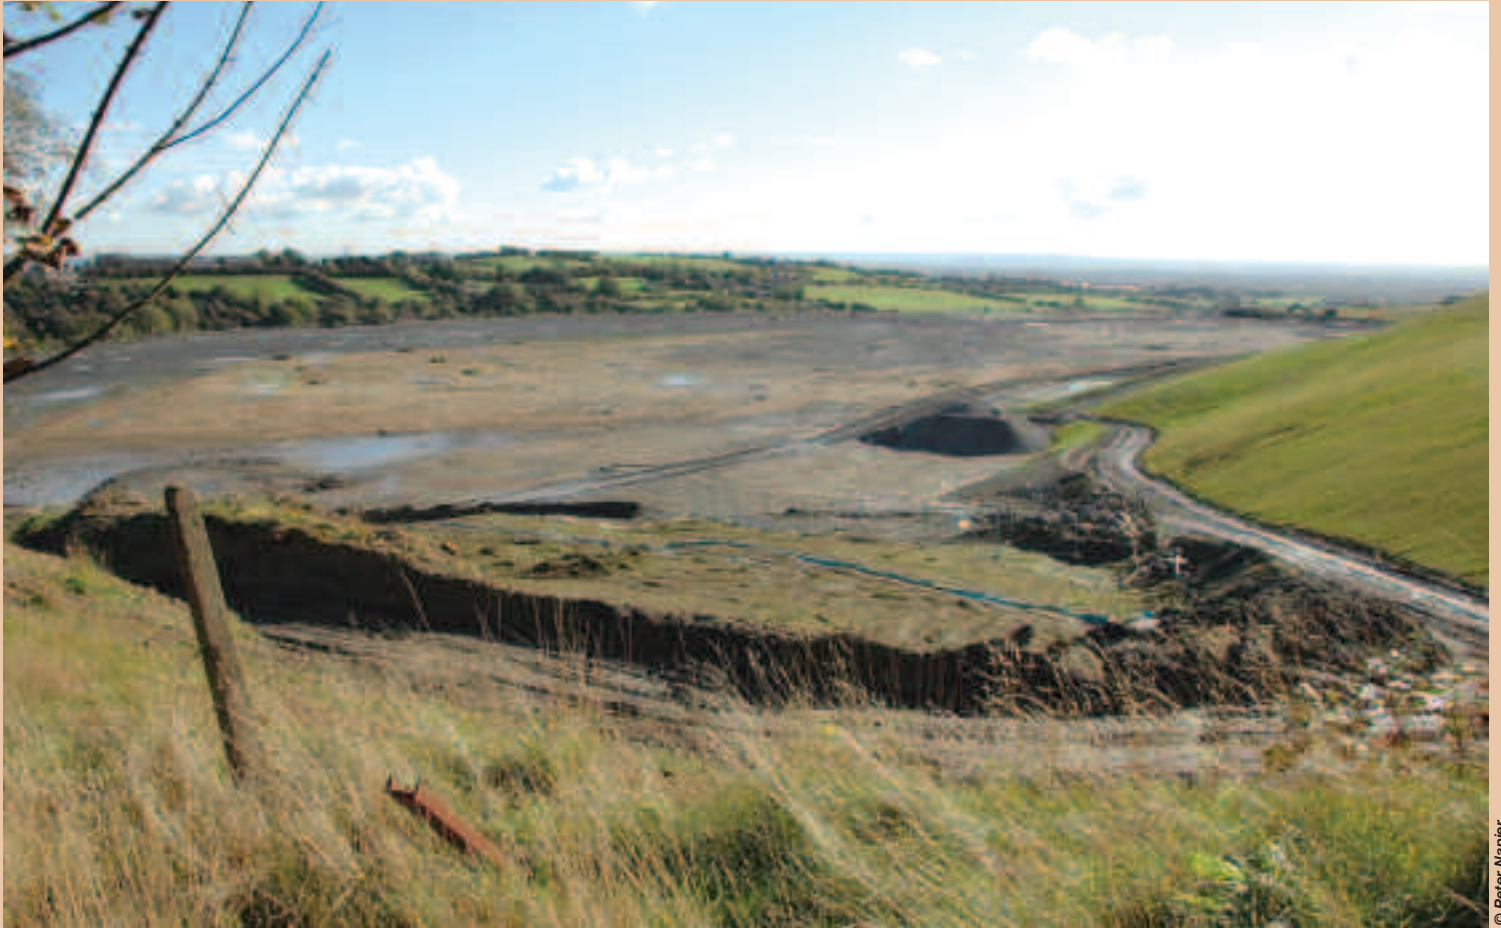
The Brymbo site in 2006 after reclamation. The area in the foreground is the fossil forest covered over with a protective membrane and soil until it can be properly protected and displayed.

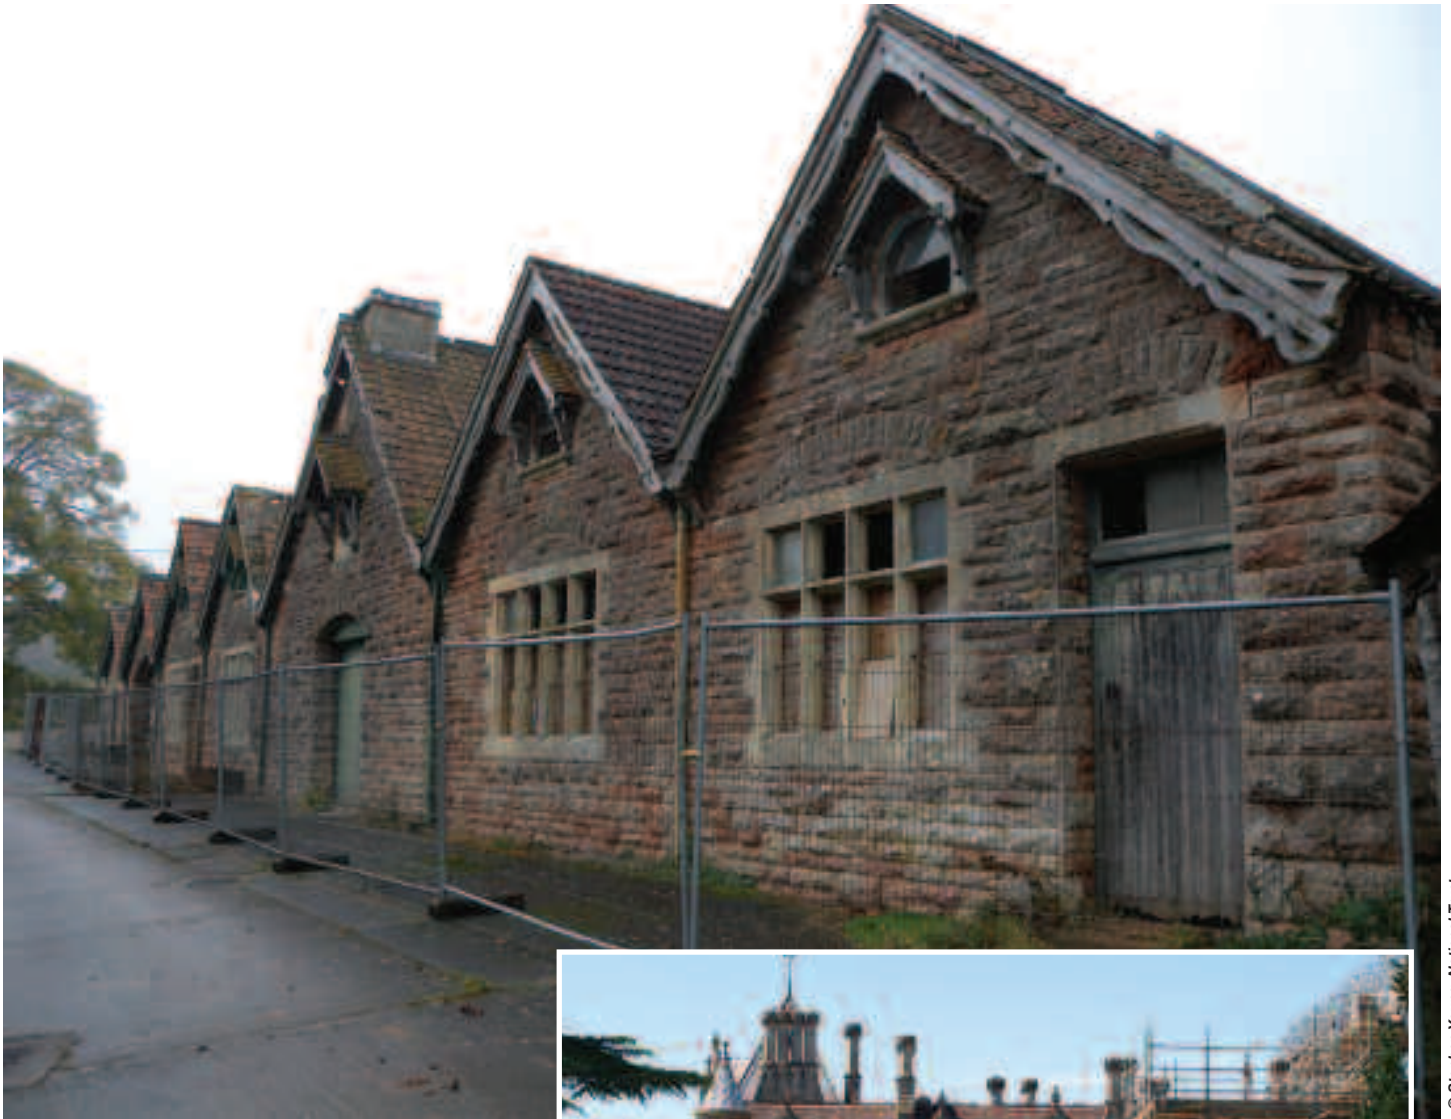
The essential starting point of work on any historic building is getting to know your subject in terms of its past, current and potential future uses. This meant many hours of background research, not just on estate history, but to gain a wider understanding of the history of farming practice and the design development of farm buildings.

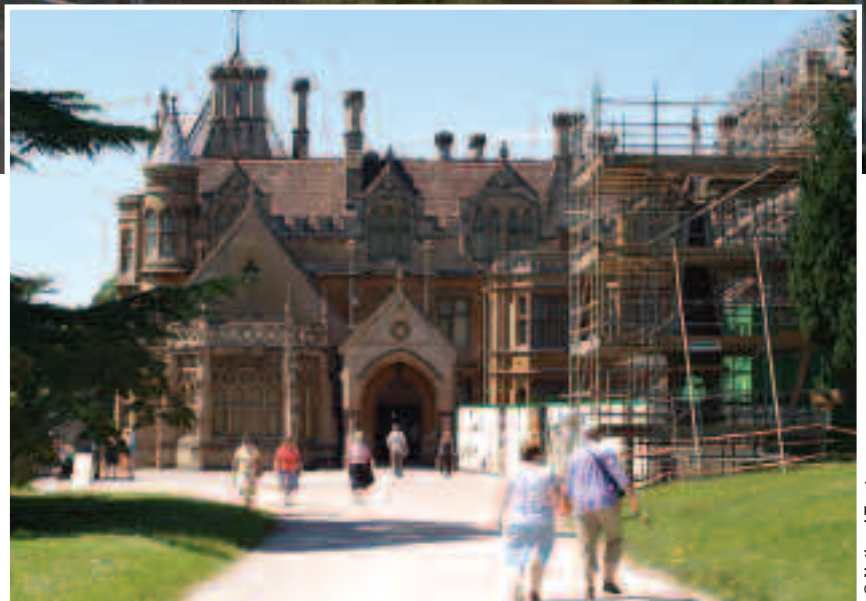
**Top: South elevation of the covered yard before works began. Inset: Tyntesfield's magnificent Gothic Revival house has also gone through extensive refurbishment**

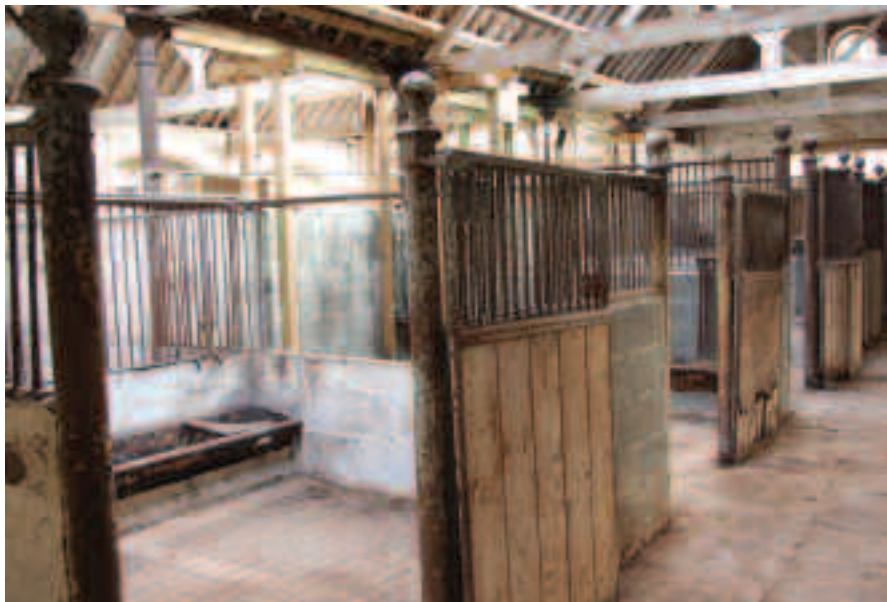
**Above: Interior shot of the covered yard before works began. Top right: Decay to valley beam and truss end bearing.**

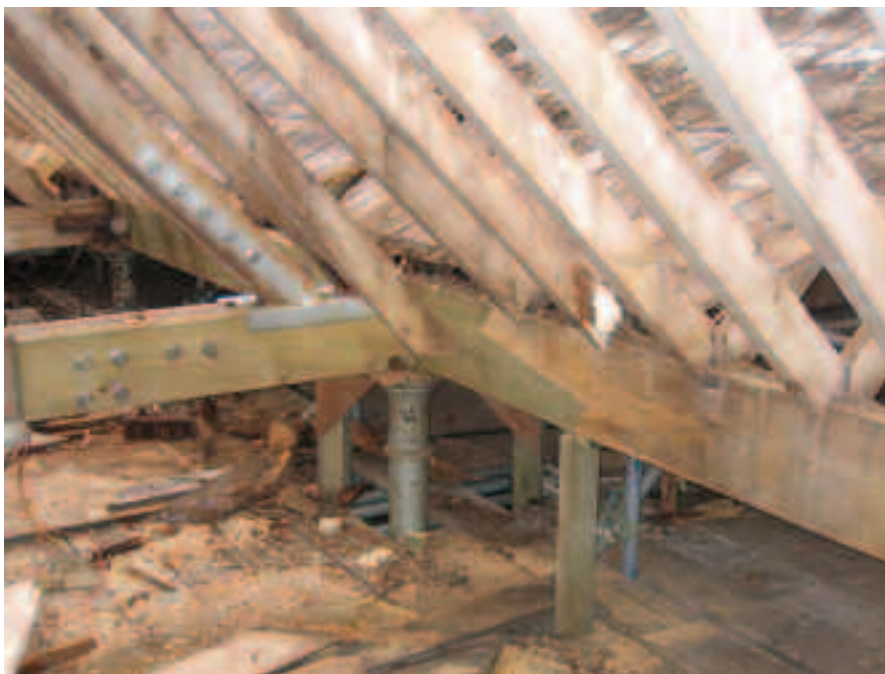
**In situ repairs to valley beams and king post roof truss**

By developing a thorough repair specification for the structure with an experienced and sensitive structural engineer, we were able to opt for restoration on a timber-by-timber basis, so that as much of the historic fabric would be preserved as was reasonably practical.

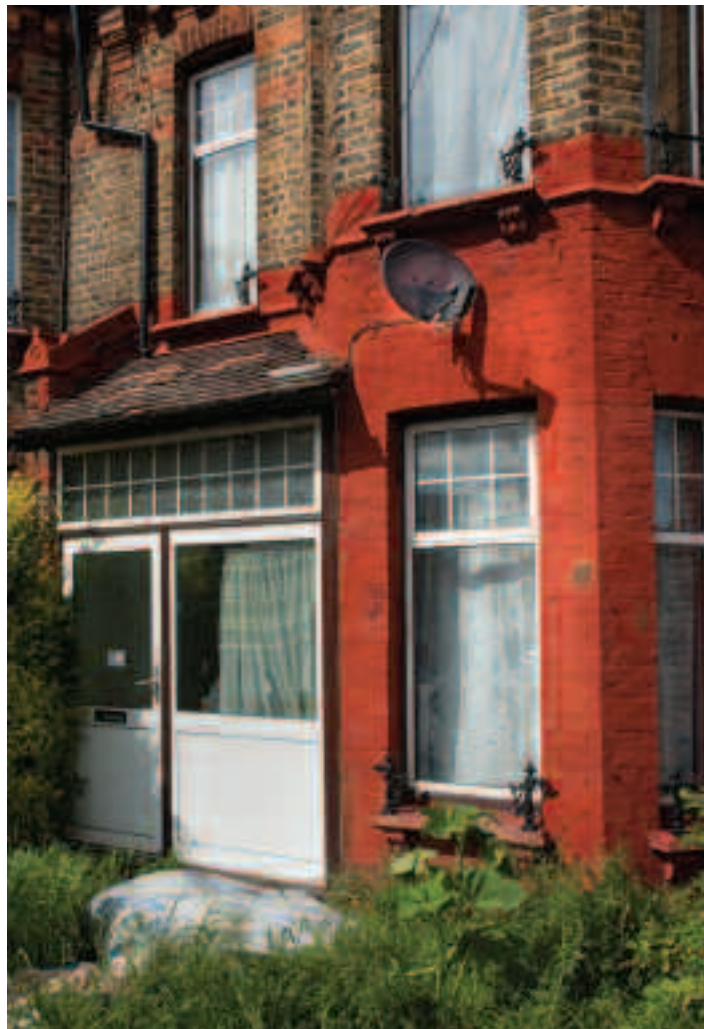
**This late 19th century terraced house in the Noel Park Conservation Area in the London Borough of Haringey has had its historic character severely eroded by inappropriate uPVC windows and doors and unnecessary painting of part of the brickwork. A survey of estate agents carried out for English Heritage suggests that the value of properties that have been insensitively altered is likely to be lower than those that retain their original features intact**

The most common cause of that loss of character was the introduction of unsympathetic replacement doors and windows. This was identified as a key issue in more than eight out of 10 conservation areas. The second most frequently mentioned threat was poorly maintained roads and pavements (six out of 10 conservation areas) followed by, in diminishing frequency of mentions, street clutter, loss of boundary walls, fences or hedges, satellite dishes, traffic management measures and alterations to front elevations, roofs and chimneys. Other threats to character – such as development pressures, which have the potential to destroy character in one knock-out blow – were mentioned much less frequently as a problem.
